Airworthiness Directives; Eurocopter France Helicopters

2012-25-04 **EUROCOPTER FRANCE:** Amendment 39-17285; Docket No. FAA-2012-1297; Directorate Identifier 2012-SW-100-AD.

This AD defines the unsafe condition as severe vibrations due to failure of laminated half-bearings (bearings). This condition could result in failure of the tail rotor and subsequent loss of control of the helicopter.

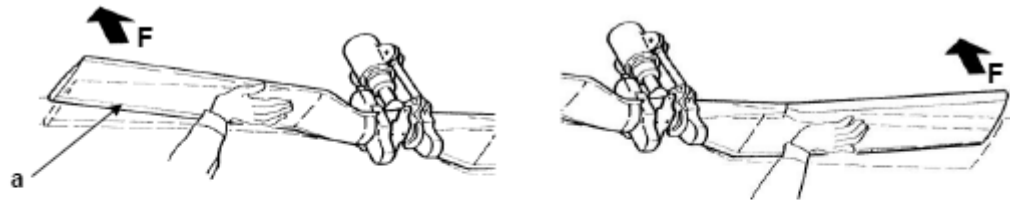
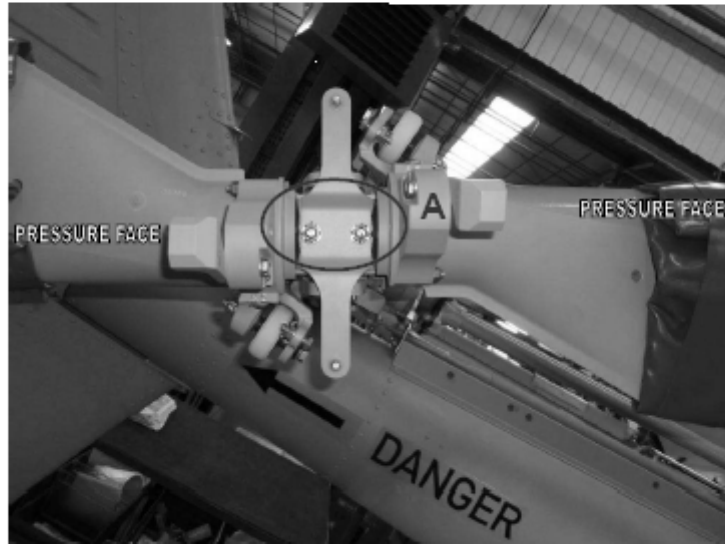
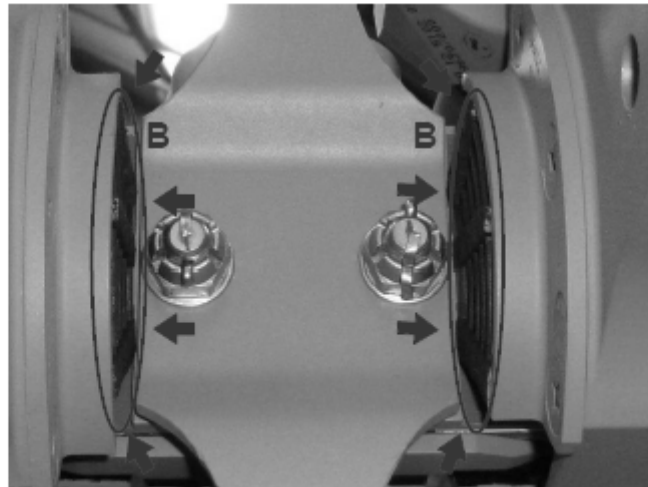
(iii) While maintaining the load, check all the visible faces of the bearings (front and side faces) in area B of DETAIL A of Figure 1 to paragraph (f) of this AD for separation between the elastomer and metal parts, a crack in the elastomer, or an extrusion (see example in Figure 2 to paragraph (f) of this AD). A flashlight may be used to enhance the check.

(ii) Apply load (F) by hand, perpendicular to the pressure face of one tail rotor blade (a), as shown in Figure 1 to paragraph (f) of this AD, taking care not to reach the extreme position against the tail rotor hub. The load will deflect the tail rotor blade towards the tail boom.

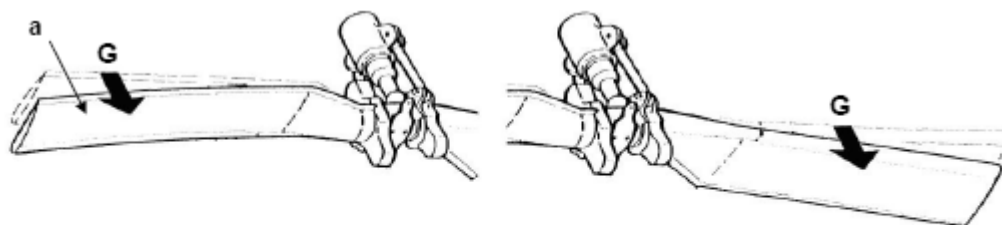
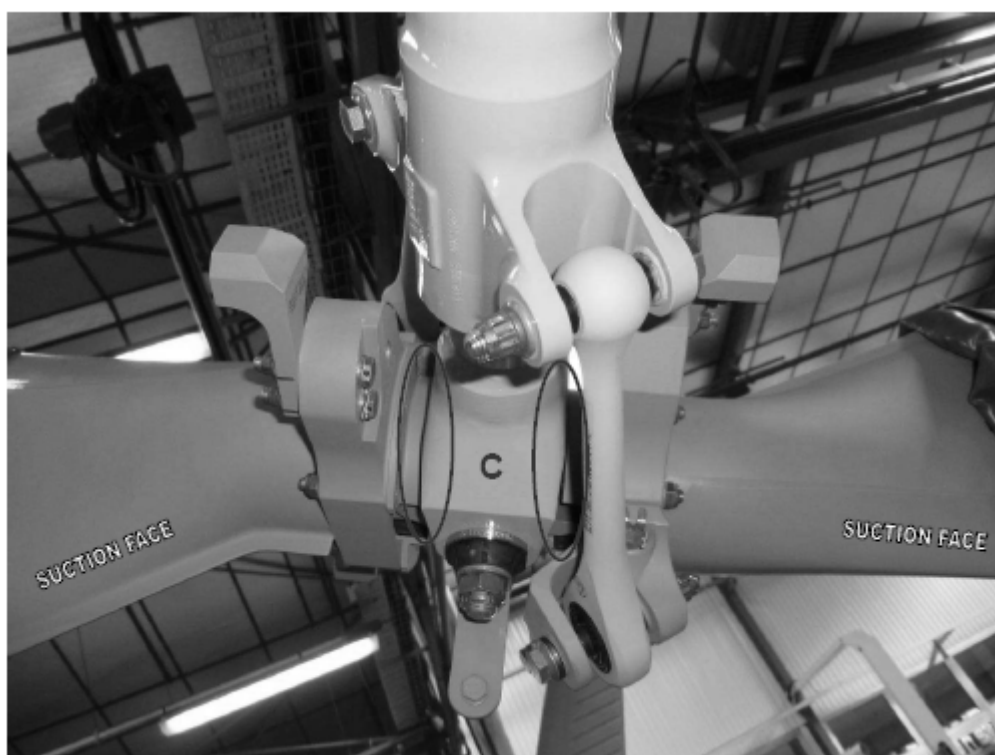
(vi) While maintaining the load, check visible faces of Area C as shown in Figure 3 to paragraph (f) of this AD for any extrusion. A flashlight may be used to enhance the check.

(v) Apply load (G) by hand perpendicular to the suction face of one tail rotor blade as shown in Figure 3 to paragraph (f) of this AD. The load will deflect the tail rotor blade away from the tail boom.

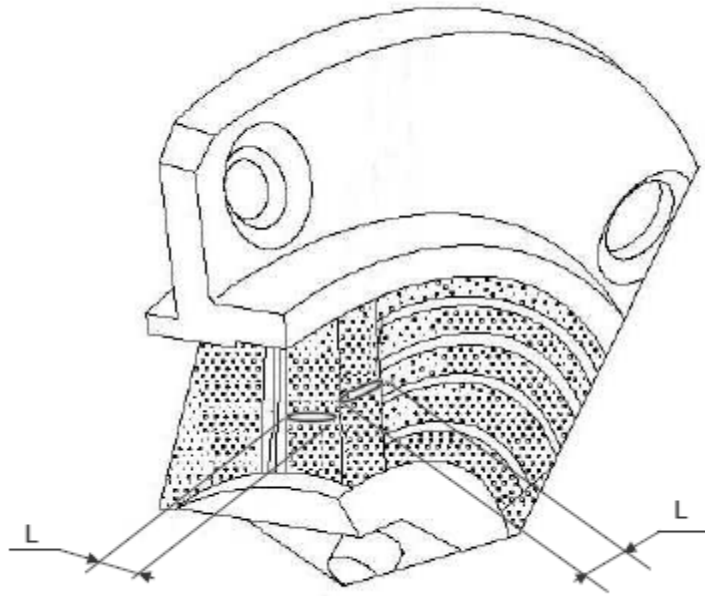
Figure 4 to paragraph (f)

(6) If there is a separation or a crack on the pressure side bearing, measure the separation or the crack. If the separation or crack is greater than 5 millimeters (.196 inches) as indicated by dimension “L” in Figure 4 to paragraph (f), before further flight, replace the four bearings with airworthy bearings.
